**Rockfield Farm  
The Elms  
Undy  
Monmouthshire  
NP26 3EL**

**A Preliminary Ecological Appraisal By:**

**December 2018**

<b>Client</b>	Monmouthshire County Council
<b>Project Name</b>	Rockfield Farm, The Elms, Undy, Monmouthshire NP26 3EL
<b>Report Title</b>	A Preliminary Ecological Appraisal
<b>File Reference</b>	GEN4014 (Revision 1)

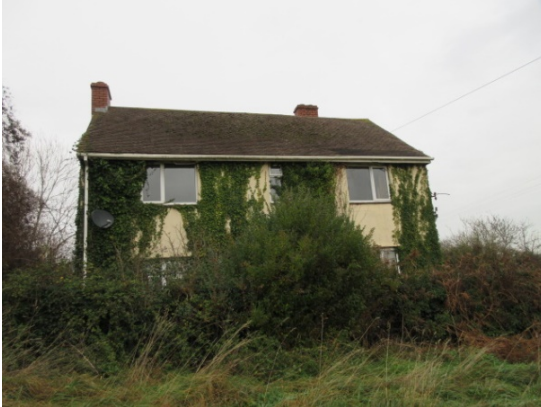
Plate 1: Farmhouse (south elevation)

- 9.2 The house has features that are often used by bats for summer day roosts, in particular pipistrelle and brown long-eared (*Plecotus auritus*) species. This building is assessed to offer a moderate level of potential, due to gaps around the roof structure and the features and materials of the roof. In accordance with national guidelines, additional assessment is recommended for this building. Demolition will need to be postponed until summer activity observations can determine with a greater degree of certainty whether the building is a bat roost or not. The presence of the four old bat droppings is puzzling as these do not signify any distinctive presence by bats.

- 10.2 Features of the house result in the need for additional targeted assessment to be conducted. Two bat activity observations (at dawn or dusk) must be carried out a time of year when bats are active and have returned to their regular, favoured roost sites. The two observations can be undertaken in May but must be a few weeks apart for the survey results to be robust and not provide a single snapshot of the bat activity at the house.

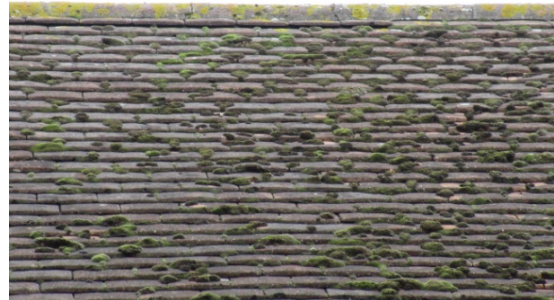
- gaps under lead flashing at the base of the western chimney;
  - gaps around the ridge area of the roof;
  - raised and missing roof tiles.
- 8.3 Holes created in the house wall for the recent asbestos survey now add a series of additional access points and roost opportunities for bats and other creatures. The house is assessed to offer a moderate level of potential for bats, and the four bat droppings indicate some presence but it is not clear what they might signify.

Plate 2: Gaps around farmhouse roof

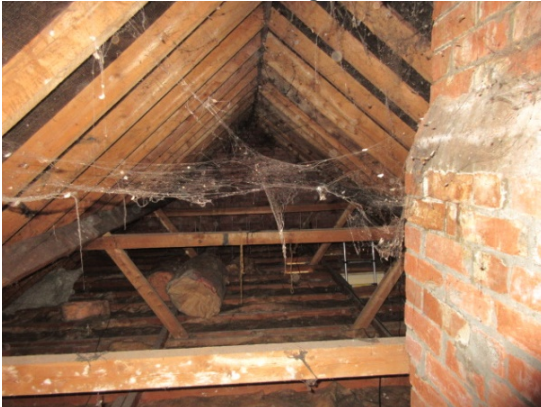
- 8.2 Survey commenced with an inspection of the house loft, which found no live bats but four old bat droppings were found on the floor of the roof space. They were small and pipistrelle sized and dispersed within the central part of the loft. All the bat droppings were crumbled to check they were indeed bat droppings, as mouse droppings were widespread on the floor of the loft. A large wasp nest (*Vespula vulgaris*) was noted inside the loft against the southern eaves close to the porch. The external inspection of the house revealed no evidence of bats, no bat droppings or staining – nothing to indicate the presence of a bat roost. However, as noted in 2014, features of the structure offer potential for bat access and roost locations. These include:

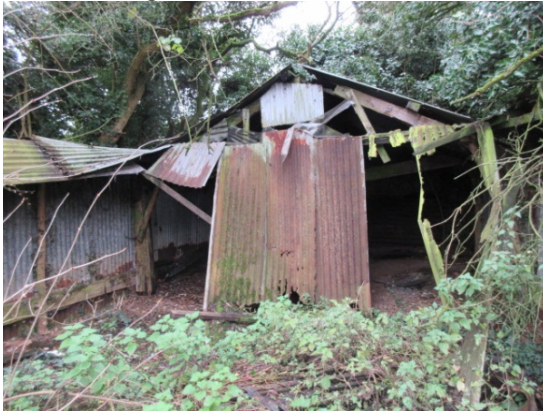
Plate 17: Garage

- 9.3 Presence of bats at all times of year was considered for this assessment and the partially collapsed garage is assessed to have low to moderate potential to be used by hibernating bats. The stone wall against the earth bank at the south-west end contains two arched recesses. These sorts of features are used by hibernating lesser horseshoe bats and crevices in the stone work have the potential to conceal other bat species. Without dismantling this feature, it is impossible to know if bats are present, and therefore a precautionary approach is recommended below so that this feature is opened up and dismantled in May 2019 at a time when bats are unlikely to make use of such a structure.

- 10.3 Removing the corrugated iron sheeting from the walls and roof of the partially collapsed garage and destroying/dismantling the stone wall feature at the south-west end must be done at a time of year avoiding the bat hibernation period of November to March inclusive. This work can be done once stable warm weather arrives such as would be typical of May. Prior to the removal of the stone wall, the wall and the two arched recesses must be visually checked closely to ensure bats or other wildlife are not present. This work must be completed in the summer and before the end of September to avoid potential transitional bat usage in the months of October and April.

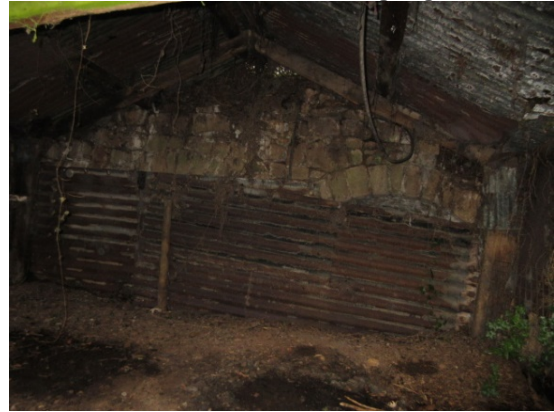
- 8.5 A feature of the semi-derelict garage structure is considered to have low to moderate hibernation potential for bats. The south-west end stone wall of the garage which is set against an earth bank contains two arched recesses partially hidden behind a panel of corrugated iron. It is the sort of feature that lesser horseshoe bats will utilise during mild winter weather. Cavities in the stone work could also be used by other bat species as a hibernation location. A summary of the survey findings are presented in Table 4 below.

Plate 18: South-west end wall of the garage

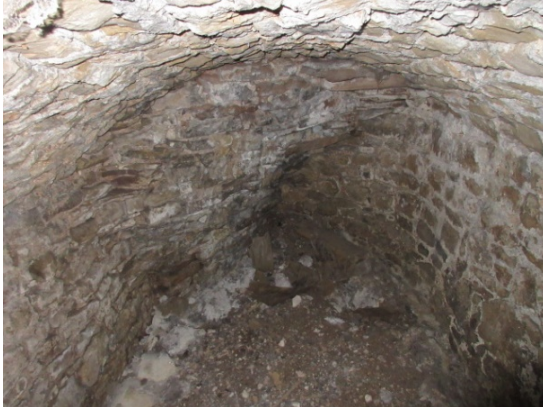
Plate 19: Arched recesses in south-west wall of garage
