Rockfield Farm
Undy
Monmouthshire
NP26 3EL

An Ecological Survey
Report By:

June 2019

Client	Monmouthshire County Council
Project Name	Rockfield Farm, Undy, Monmouthshire NP26 3EL
Report Title	An Ecological Survey Report
File Reference	GEN4014 (Revision 2)

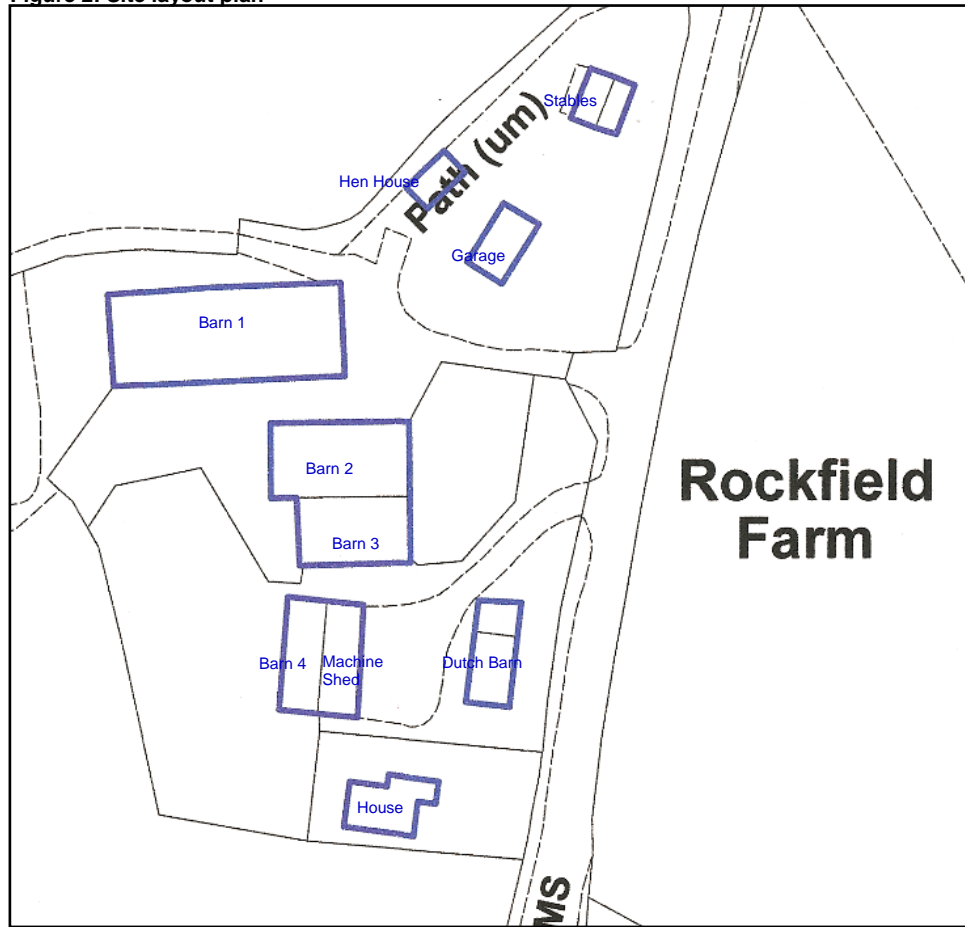
Figure 2: Site layout plan

- 5.1 A full site description is provided in the survey report of 2014. A summary of key features of the ten structures is shown below in Table 3. A site layout plan is provided in Figure 2 (see Appendix II), which shows the position of the farm buildings in relation to each other.

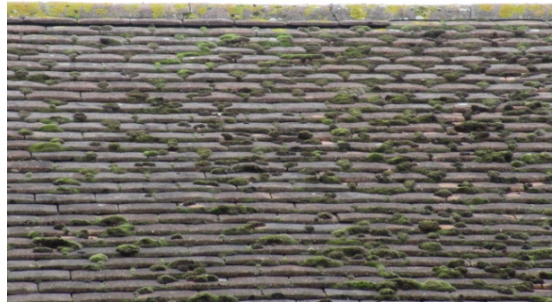
Plate 2: Gaps around House roof

- gaps under lead flashing at the base of the western chimney;
- gaps around the ridge area of the roof;
- raised and missing roof tiles.

- 8.3 Holes created in the House wall, for the recent asbestos survey, have now added a series of additional access points, and roost opportunities for bats and other creatures. The House is assessed to offer a moderate level of potential for bats, and the four bat droppings indicate some presence but it is not clear what they might signify.

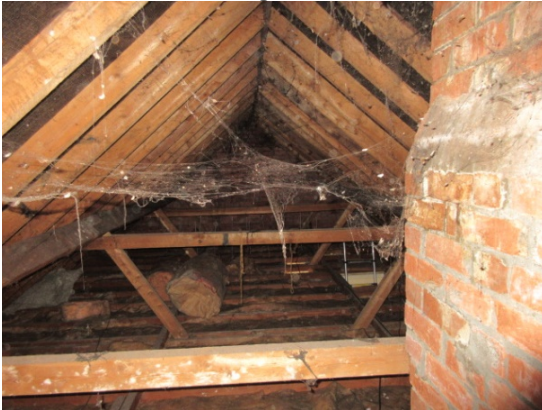
Plate 3: House loft looking west

- 8.2 The PRA, in December 2018, commenced with an inspection of the House loft, which found no live bats, but four old bat droppings, on the floor of the roof space. They were small and

pipistrelle sized, and dispersed within the central part of the loft. All the bat droppings were crumbled to check they were indeed bat droppings, as mouse droppings were widespread on the floor of the loft. A large, inactive, wasp nest (*Vespula vulgaris*), was noted inside the loft, against the southern eaves close to the porch. The external inspection of the House revealed no evidence of bats, no bat droppings or staining – nothing to indicate the presence of a bat roost. However, as noted in 2014, features of the structure offer potential for bat access and roost locations. These include:

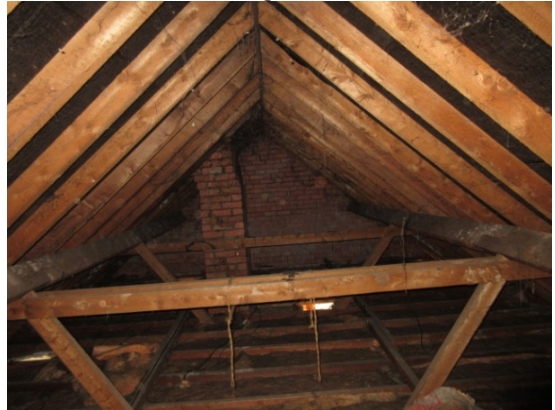
Plate 4: House loft looking east

- 1.3 In December 2018, a small number of old bat droppings (4) were found in the loft space of the house. This building remained intact although recent new gaps had been created whilst testing the dwelling for the presence of asbestos. The evidence of the bat droppings was not conclusive as they were old and found scattered within the central part of the loft. To establish with greater certainty whether the house contained bat roosts, the winter scoping survey was followed up by two dusk bat emergence/activity observations in May 2019. No bats emerged, and it is concluded that the house is not a bat roost. The presence of the low number of bat droppings is however enigmatic, and is attributed to historic and brief opportunistic bat activity when the property was occupied.

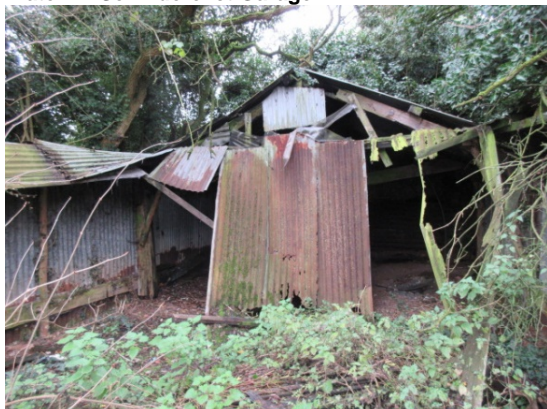
Plate 17: Semi-derelict Garage

- 1.4 Two stone arch recesses forming the rear (south-west) wall of the Garage were a feature of this building, and identified to offer potential for bats. The December 2018 survey report concluded that they offered possible hibernation usage and were likely to be attractive to lesser horseshoe bats. Recommendations were made for the summer demolition of this building, but when the recesses were examined in late May 2019, a single torpid lesser horseshoe was roosting in the eastern recess. The presence of this bat means the Garage is a summer day roost for this species, and the demolition of the Garage and destruction of the two arches will require a European Protected Species licence issued by Natural Resources Wales before work commences which affects the bat roost. Work to dismantle the Garage cannot commence until such time as a licence is obtained. Details about licence process and a scheme of mitigation are provided in this report.

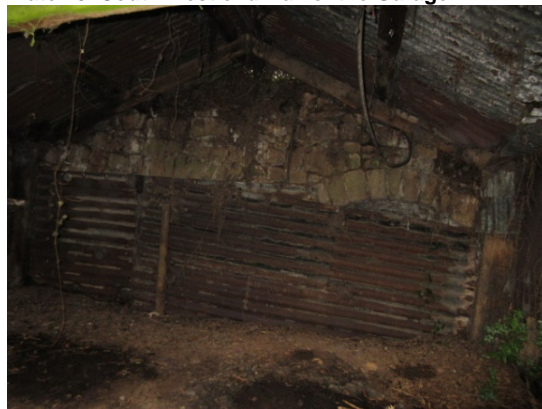
Plate 18: South-west end wall of the Garage

- 8.5 A feature of the semi-derelict Garage is considered to have low to moderate hibernation potential for bats. The south-west end stone wall of the Garage which is set against an earth bank contains two arched recesses partially hidden behind a panel of corrugated iron. It is the sort of feature that lesser horseshoe bats (*Rhinolophus hipposideros*), will utilise during mild winter weather. Cavities in the stone work could also be used by other bat species as a hibernation location. A summary of the survey findings are presented in Table 5 below.

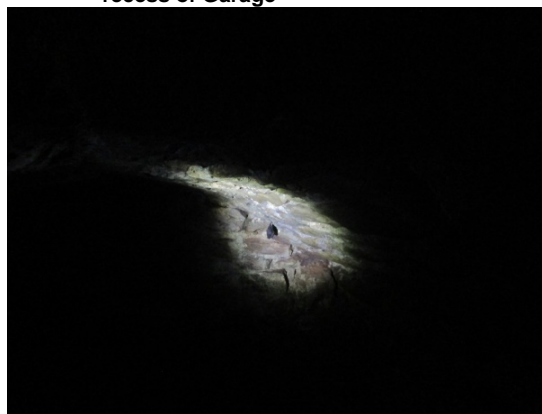
Plate 21: Lesser horseshoe bat in left (east) arched recess of Garage

- 9.3 During the visit in late May 2019, it was established that the semi-derelict Garage is a bat roost, as evidenced by the presence of a single lesser horseshoe bat. This building was originally assessed to have low to moderate potential to be used by hibernating bats. The stone wall against the earth bank at the south-west end contains two arched recesses. These sorts of features are used by hibernating lesser horseshoe bats and crevices in the stone work have the potential to conceal other bat species. Without dismantling this feature, it is impossible to know if bats are present, and therefore a precautionary approach was recommended so that this feature be opened up and dismantled outside of the hibernation period.

- 9.4 However, the inspection of this feature in late May 2019 identified a summer day roost of a single lesser horseshoe bat. The lack of any obvious quantity of bat droppings within the recess suggests this feature is an occasional day roost. Lesser horseshoe bat is classed as rare and endangered, but south-east Wales supports a nationally important population. These bats will exploit roosting opportunities in sheds and outbuildings where there is access, for day roosting and night roosting by low numbers of animals likely to be males and non-breeding females. The presence of this bat means that the destruction of the semi-derelict Garage and the arched recesses will result in the destruction of a bat roost.

- 9.5 A European Protected Species (EPS) licence will be required from Natural Resources Wales (NRW), before any work is done which affects roosts and obstructs the bat exit/entry points. Further information concerning the EPS licence and other recommendations are made below. A scheme of mitigation is provided below which describes the provision of a night roost feature tested by the Vincent Wildlife Trust on Cathedine Common near Llangors Lake, and it is therefore referred to as the Cathedine night roost design.

- 9.7 The bat(s) must not be left without alternative roost opportunities at the development site. Timing of the building demolition work will be important to ensure that a new night roost feature is available to the lesser horseshoe bat(s), before demolition occurs (see recommendations below).
