**Rockfield Farm  
The Elms  
Undy  
Monmouthshire  
NP26 3EL**

**A Preliminary Ecological Appraisal By:**

**December 2018**

<b>Client</b>	Monmouthshire County Council
<b>Project Name</b>	Rockfield Farm, The Elms, Undy, Monmouthshire NP26 3EL
<b>Report Title</b>	A Preliminary Ecological Appraisal
<b>File Reference</b>	GEN4014 (Revision 1)

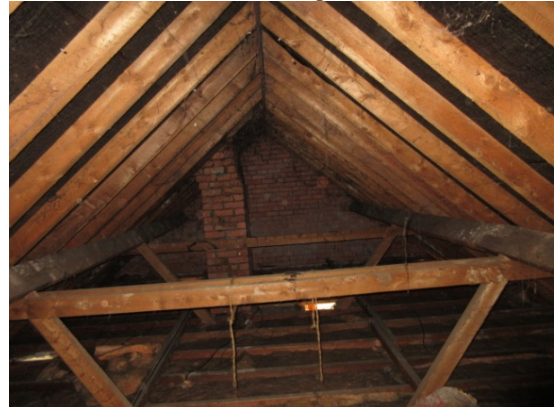
Plate 4: Farmhouse loft looking east

- 1.3 A small number of old bat droppings (4) were found in the loft space of the house. This building remains intact although recent new gaps have been created whilst testing the dwelling for the presence of asbestos. The evidence of the bat droppings was not conclusive as they were old and found scattered within the central part of the loft: they are possibly a consequence of an occasional bat presence, but the loft is swathed in great curtains of cobwebs. This building retains moderate potential to be a bat roost, and to comply with national guidelines, it will need to be assessed in the summer active period of May to September with a minimum of two dusk bat emergence/activity observations. Recommendations are made in this report to this effect.
